Investigation Report - Japanese and English Version (Summary)

PE02-039

T100 clutch pedal part dash panel cracking failure

1. Problem: Cracking of clutch-pedal bracket attachment dash panel, causing the bracket to move, so that the start switch does not come on, and the engine cannot be started

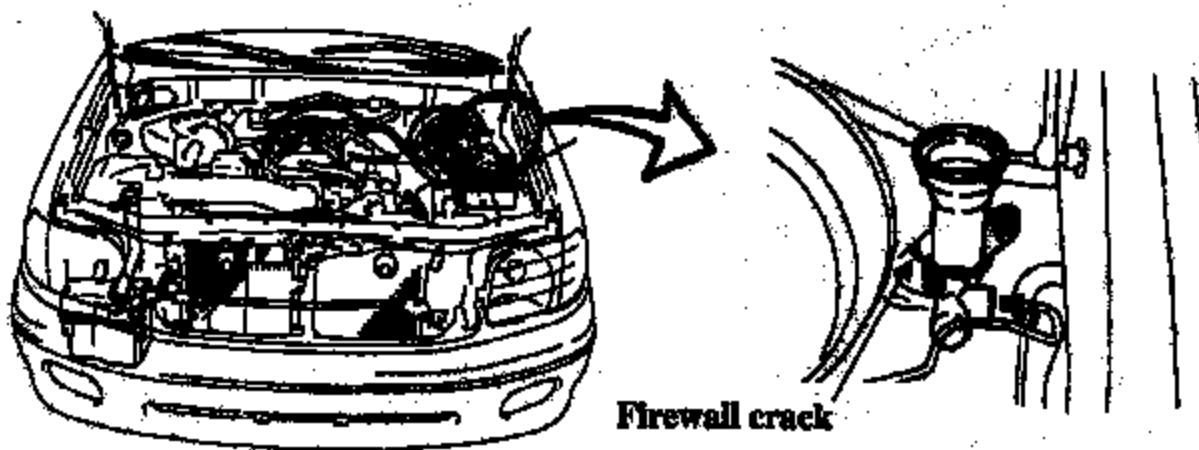
Crack in Firewall

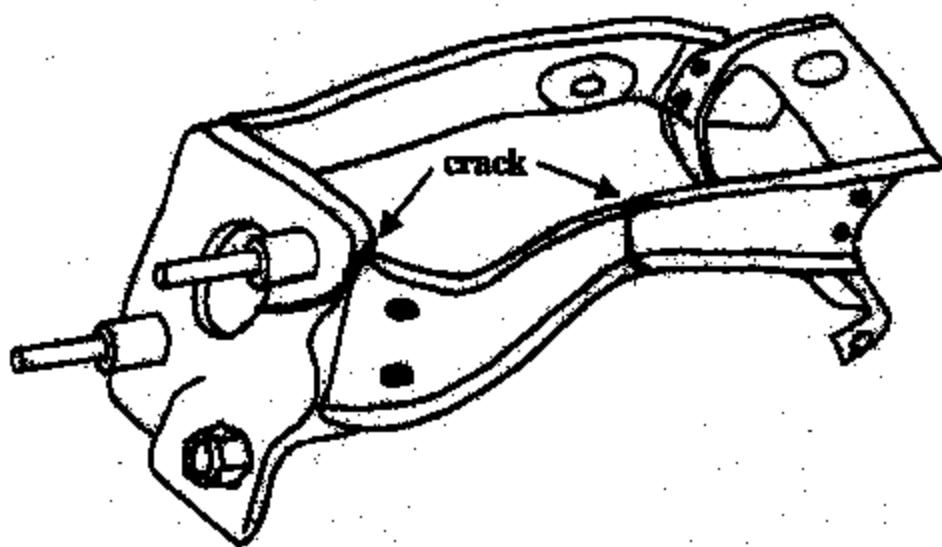
Crack in clutch pedal bracket

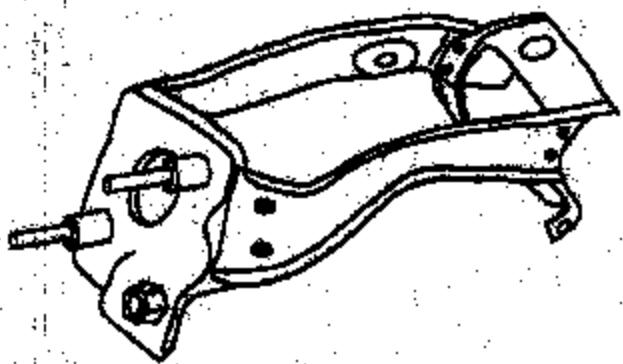
No Crack

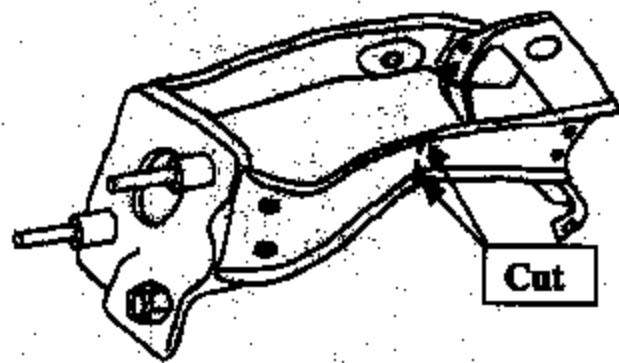
Small Crack

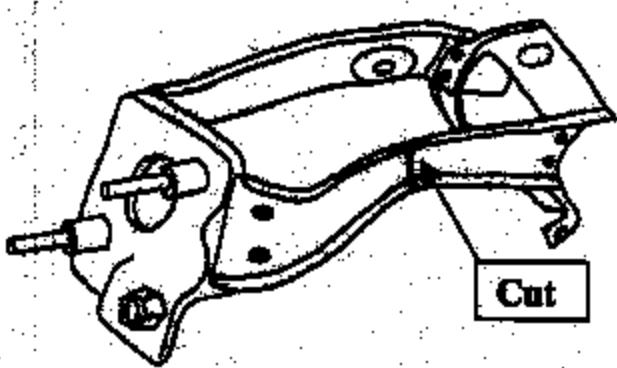
Medium Crack

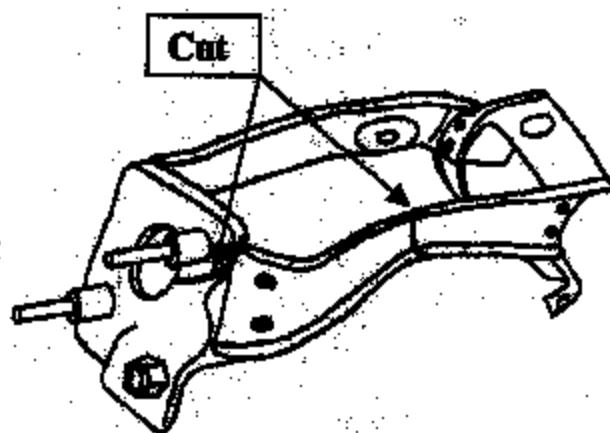
Large Crack
